62-80 Papakura-Clevedon Road  
Clevedon  
Clevedon Properties Limited

Project No. 33041

**BUN60407077: 62-80 PAKURA-CLEVEDON ROAD, CLEVEDON, AUCKLAND – SITE VALIDATION REPORT  
V2**

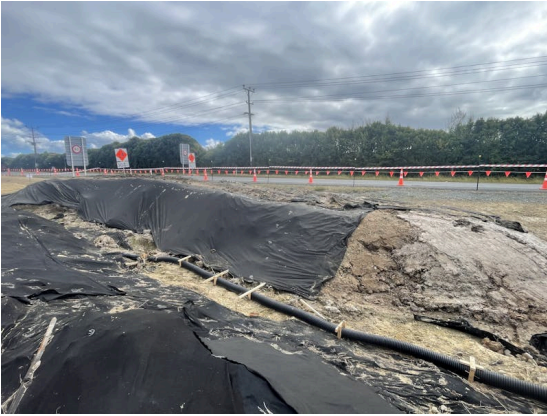
Excluded from the scope of works

Client has arranged for soil testing of encompassing soil for asbestos by a third party. The soil is to be excluded from the scope of works and thus this clearance.

However, it is recommended that the removal area is to stay cordoned off until the results of the soil testing has returned (only brought down if clear).

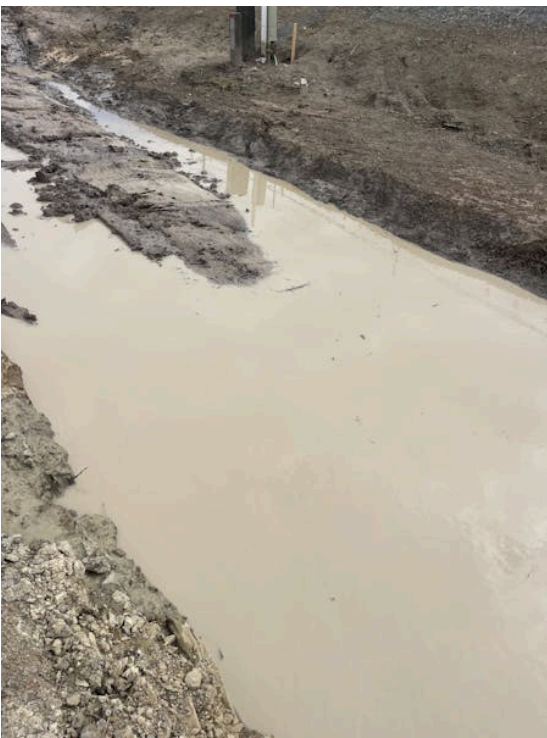
Visual Clearance - Removed

Earth water is present within the area the pipe has been removed as there is a continuous flow of water from the original source. There area below however, is visually clear of any asbestos containing materials and debris.

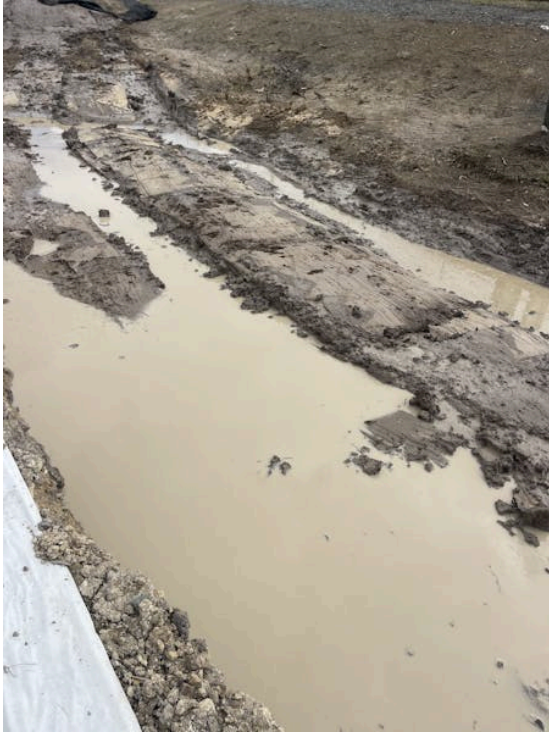
**Visual Clearance - Removed**

Earth water is present within the area the pipe has been removed as there is a continuous flow of water from the original source. There area below however, is visually clear of any asbestos containing materials and debris.

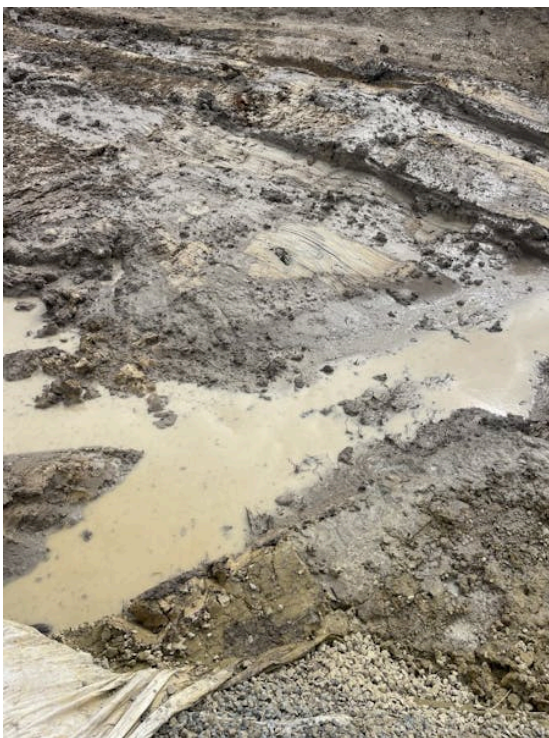
**Visual Clearance - Removed**

Earth water is present within the area the pipe has been removed as there is a continuous flow of water from the original source. There area below however, is visually clear of any asbestos containing materials and debris.

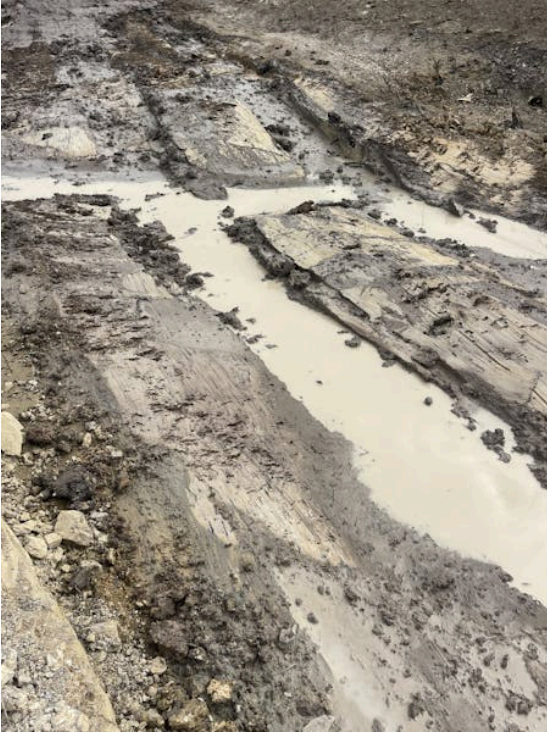
**Visual Clearance - Removed**

Earth water is present within the area the pipe has been removed as there is a continuous flow of water from the original source. There area below however, is visually clear of any asbestos containing materials and debris.

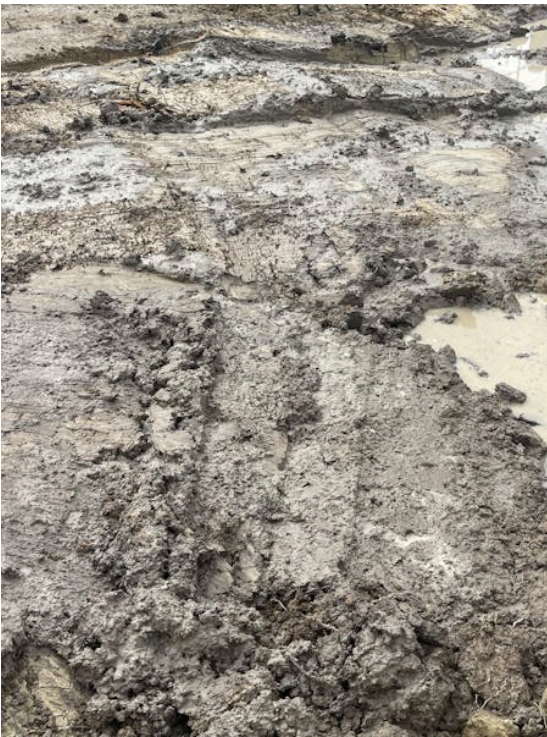
**Visual Clearance - Removed**

Earth water is present within the area the pipe has been removed as there is a continuous flow of water from the original source. There area below however, is visually clear of any asbestos containing materials and debris.

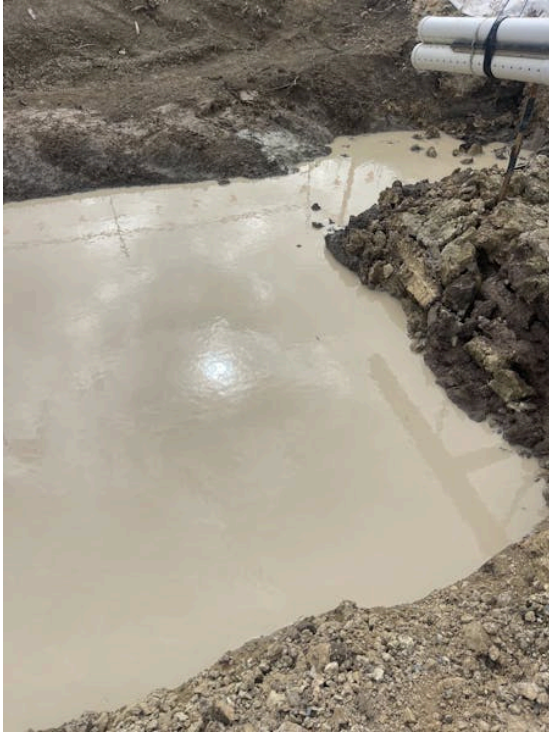
**Visual Clearance - Removed**

Earth water is present within the area the pipe has been removed as there is a continuous flow of water from the original source. There area below however, is visually clear of any asbestos containing materials and debris.

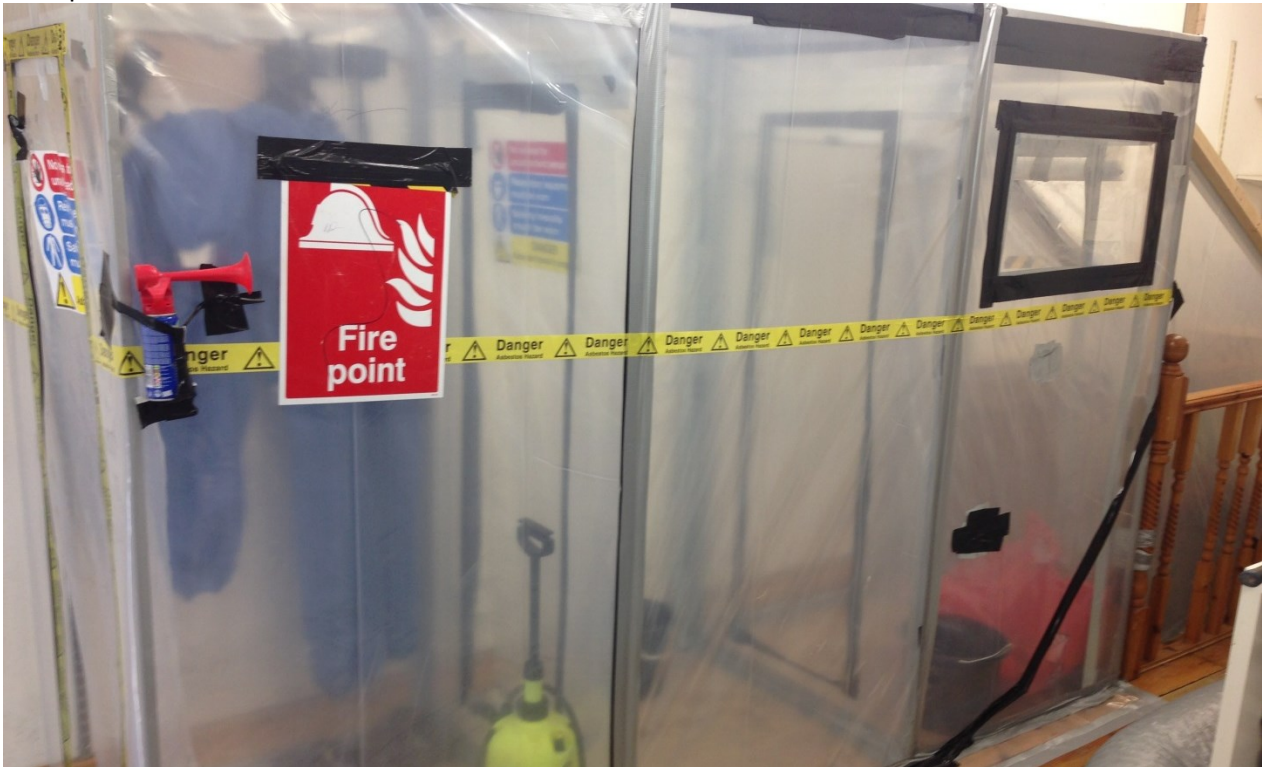
### 11.2 Decontamination Unit

A 3-stage kit-set decontamination unit will be constructed in the decontamination area. See image below for example.
